NWS Form E-5 U.S. DEPARTMENT OF COMMERCE NATIONAL OCEANIC AND ATMOSPHERIC ADMINISTRATION NATIONAL WEATHER SERVICE MONTHLY REPORT OF HYDROLOGIC CONDITIONS	HYDROLOGIC SERVICE AREA: Pocatello, Idaho
	REPORT FOR: MONTH: May YEAR: 2011
TO: Hydrologic Operations Division, W/OH2 National Weather Service National Oceanic and Atmospheric Administration Silver Spring, Maryland 20910	SIGNATURE Troy Lindquist Service Hydrologist
DATE: June 23, 2011	
When no flooding occurs, include miscellaneous river conditions, such as significant rises, record low stages, ice conditions, snow cover, droughts and hydrologic products issued (NWS Instruction 10-924).

Overview

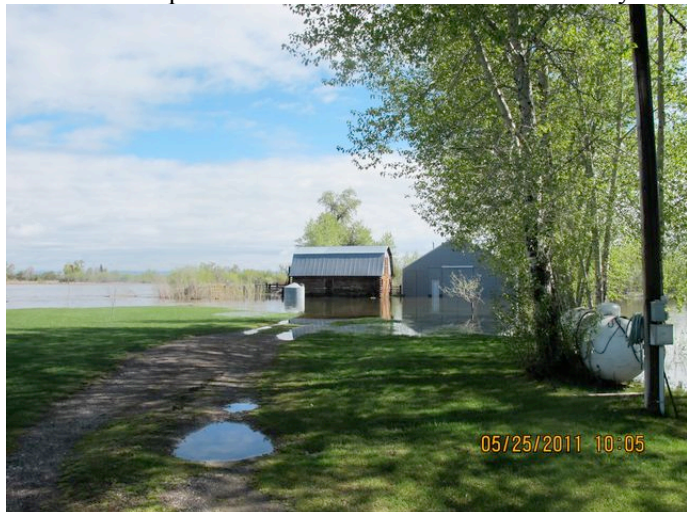
The Henrys Fork River at St. Anthony (ANTI1) rose to minor flood stage on May 25 and 26. Flood stage is 7.0 feet and the river crested at 7.44 feet. A property about one mile east of St. Anthony along old Highway 20 had water surrounding it with a small amount of water in the crawl space and outbuildings of another property were flooded. Flooding of lowlands and pasturelands occurred near St. Anthony.

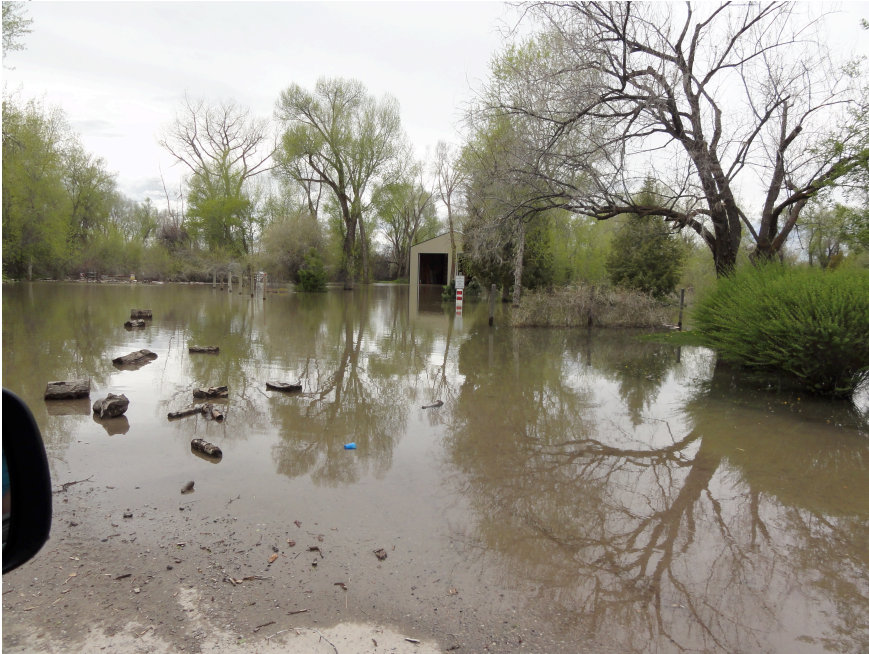
The Snake River near Shelley (SHYI1) reached flood stage on May 16 and remained above flood stage through the end of the month. The river rose to major flood stage and a crest of 13.15 feet on May 28. County Road 700 North southwest of Firth was closed. A number of homes along 700 North were surrounded by water, flooding yards and several outbuildings. In Firth the Riverview Arena was partially underwater and extensive flooding of lowlands and agricultural fields occurred adjacent to the river between Firth and Rose.

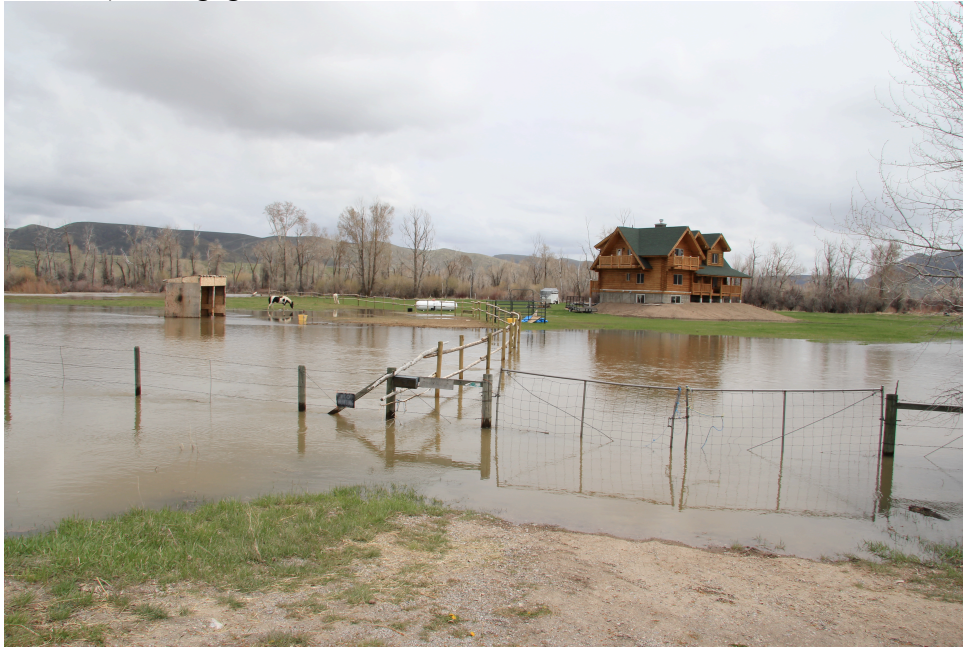
Bear Lake County - extensive lowland and field flooding occurred along the Bear River upstream of Stewart Dam. Two homes in the Dingle area were surrounded by water. Water encroached on some outbuildings and agricultural supplies were flooded in low lying areas. Water covered a portion of Pegram Road near the town of

Pegram. Water flowed across Poverty Flat Road near the intersection with Pegram Road. The Bear Border (BRBW4) river gage was inundated with water.
